SUSTAINABLE DESIGN *Switched Sites Made Design of 'Green Infrastructure' College Building More Challenging*

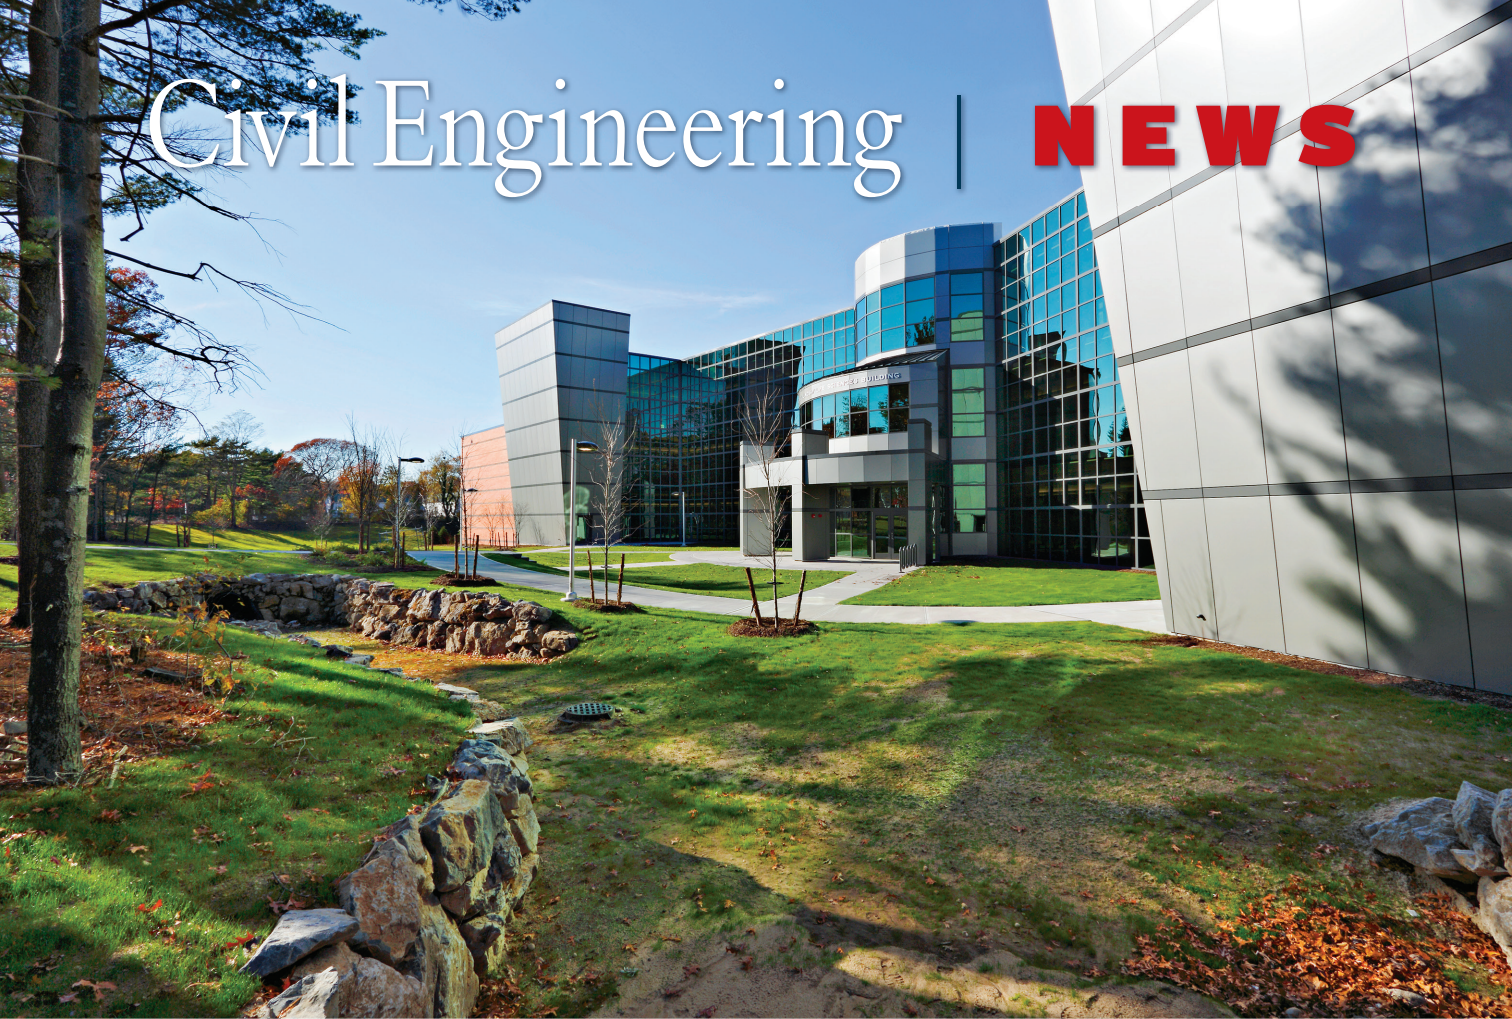
The so-called green infrastructure of Suffolk County Community College's William J. Lindsay Life Sciences Building features a combination of large swales, retaining walls, and new and reused pipes that is designed to handle drainage in as sustainable, visible, and publicly accessible a way as possible.

One swale was constructed around the north, or higher, side of the building, and the other goes around the south, or lower, side; both direct water to the wet meadow on the western side of the building. The swales feature moss-covered rock retaining walls utilizing geotextile fabric filters, the largest wall being 8 ft tall and 80 ft long. The bottoms of the swales are covered in gravel, fabric filters, and river rock roughly 6 in. in diameter. The diffusion wells and leaching pools, which are up to 10 ft in diameter and 10 ft deep, are located within the swales and in the wet meadow itself. As a pool fills with storm water during a heavy rain, the water first recharges into the underlying soil through holes in the concrete structure; if the water exceeds the recharge rate of the leaching pool, it eventually bubbles up through a grate in the swale, then flows toward the wet meadow, in some areas through pipes that pass beneath paved sidewalks.

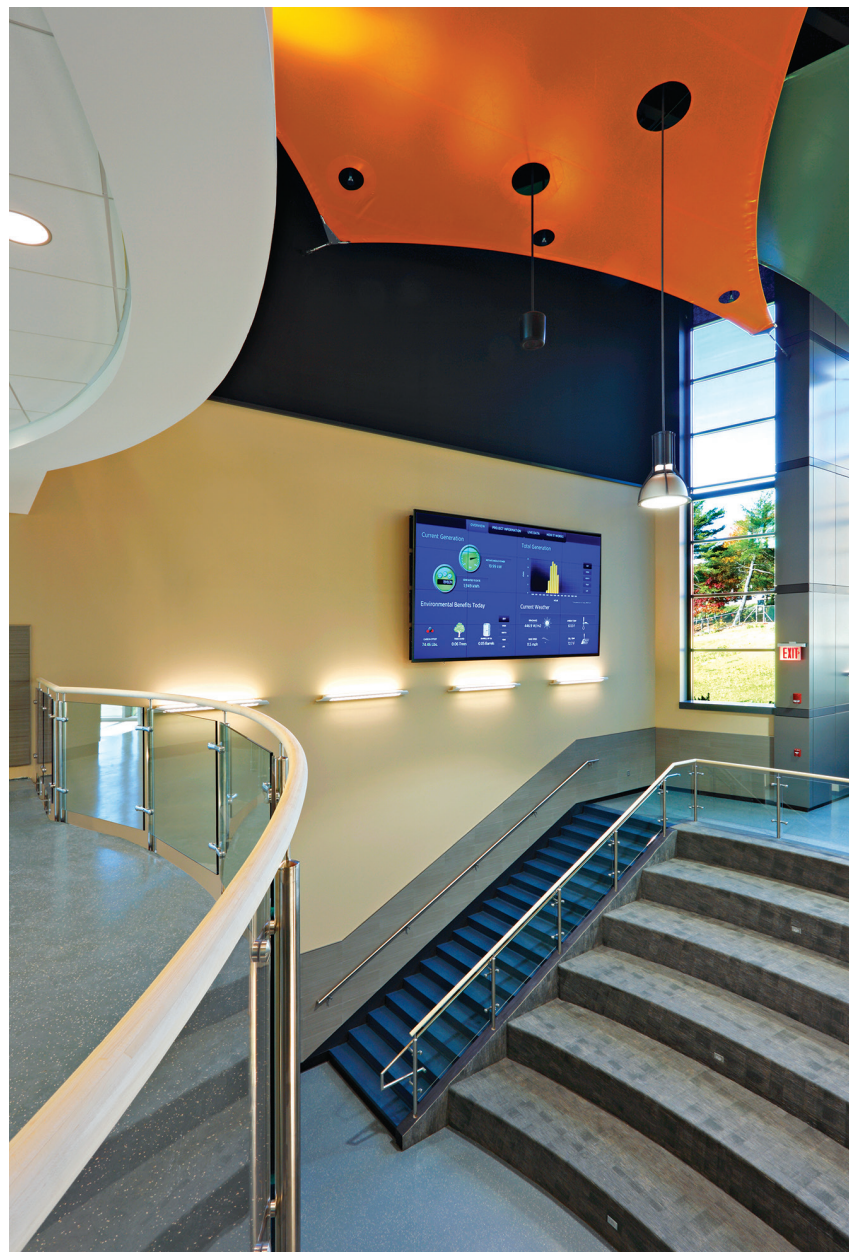
Interactive displays and kiosks provide data on the building's energy performance, including power usage and the operation of the heating, ventilation, and air-conditioning system.

than 60 percent of the building's electricity needs. Inside the building, much of the mechanical, electrical, and plumbing ductwork is exposed, and kiosks and interactive displays provide real-time data on the building's energy performance, including power usage and the performance of the heating, ventilation, and air-conditioning system.
